L1970450003 – Will  
Carlstrom Landfill  
ILD 980497721  
SF/HRS

**CERCLA  
EXPANDED SITE INSPECTION REPORT**

**Carlstrom Landfill**

**September 9, 2004**

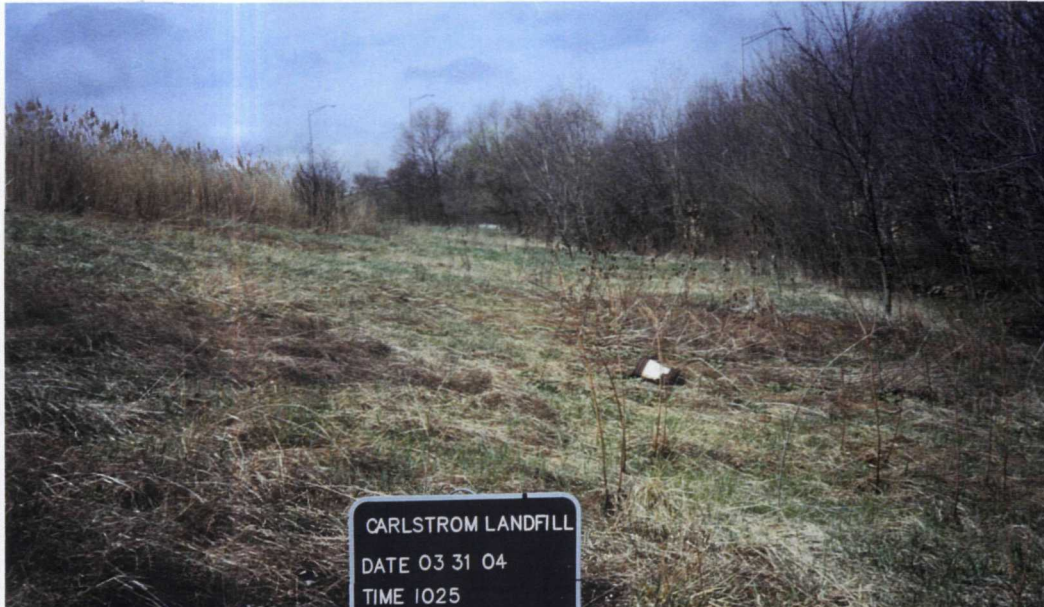
COMMENTS: Picture taken toward: West.		
Photo Number 25.		
Sample X108 was collected on the north side approxi-		
mately 300 feet east of X107.

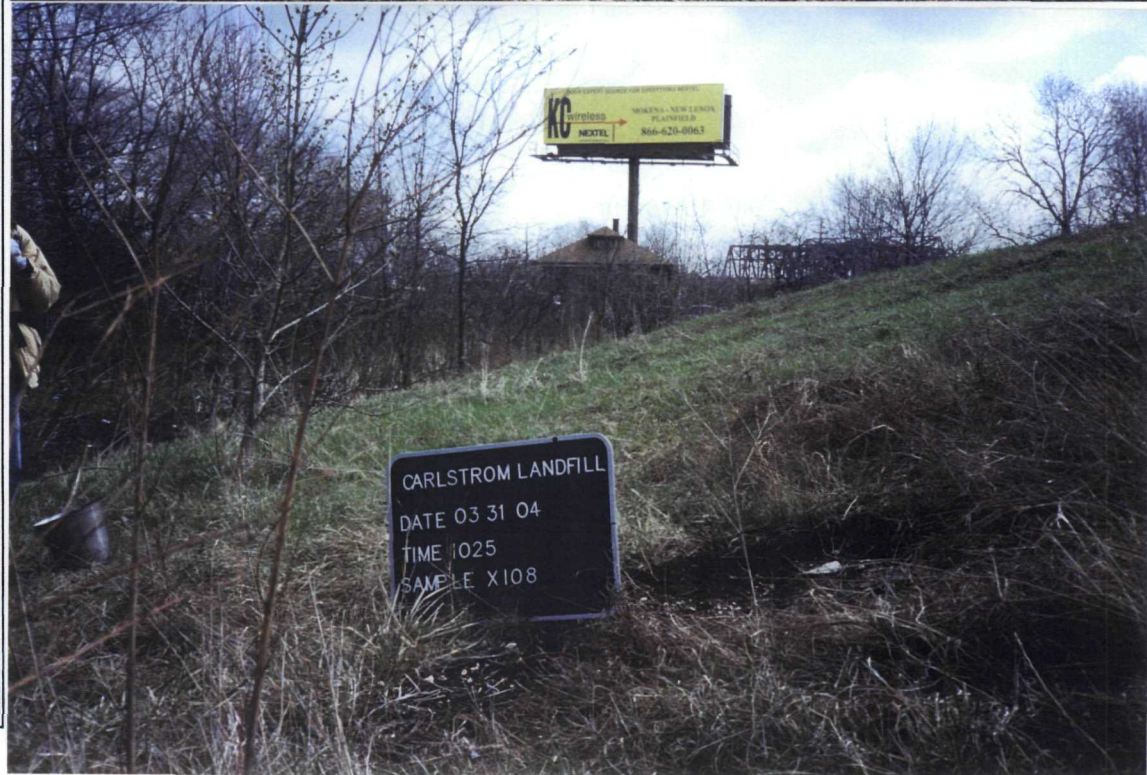
DATE: 3/31/04
TIME: 10:25
PHOTOGRAPH TAKEN BY: R. CASPER
COMMENTS: Picture taken toward: East.
Photo Number 26.
Sample X108. The house in the back-
ground below the sign uses a private
well for drinking.

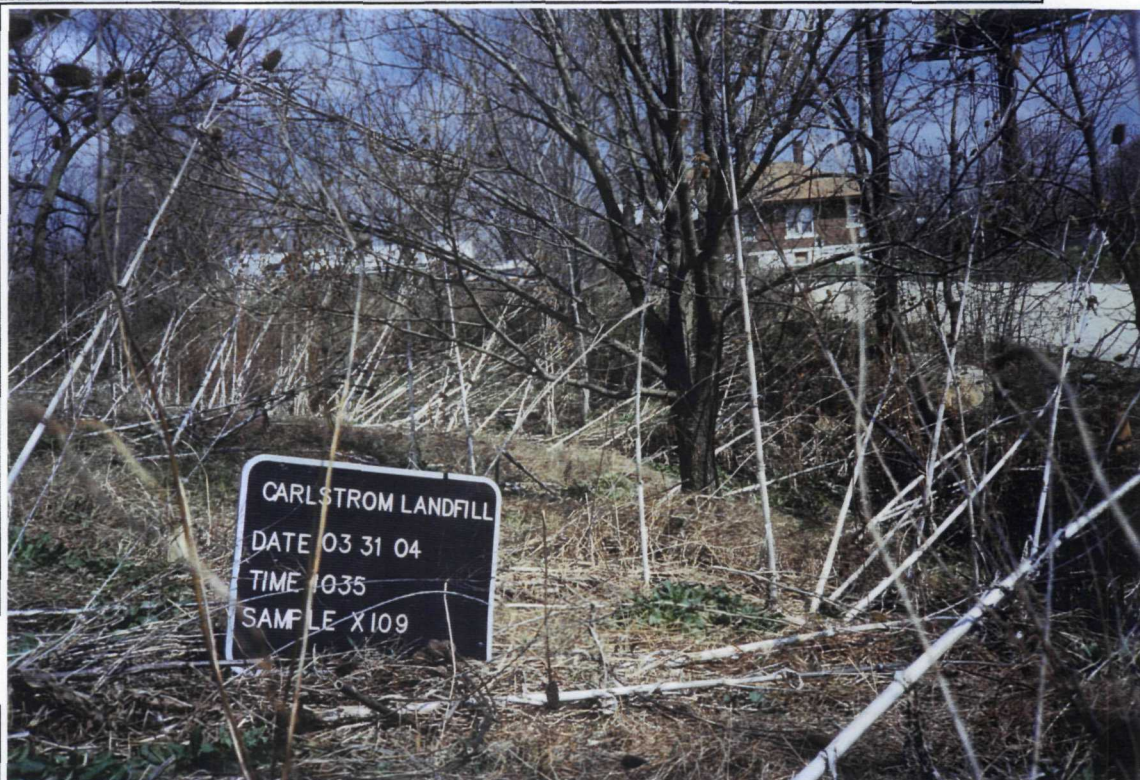
Sample X109 was  
collected on the  
east side. The  
ditch at right  
drains I-80 ramp.

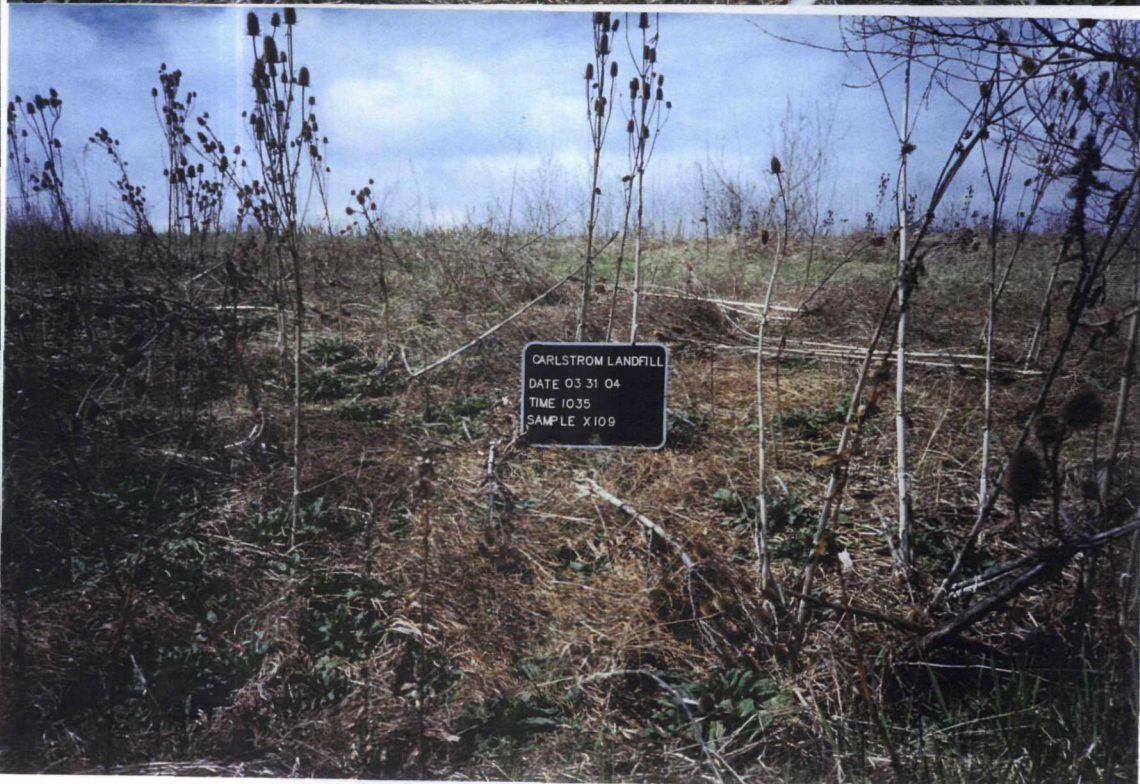
Sample X109. The  
sample consisted  
of a black silty  
clay.

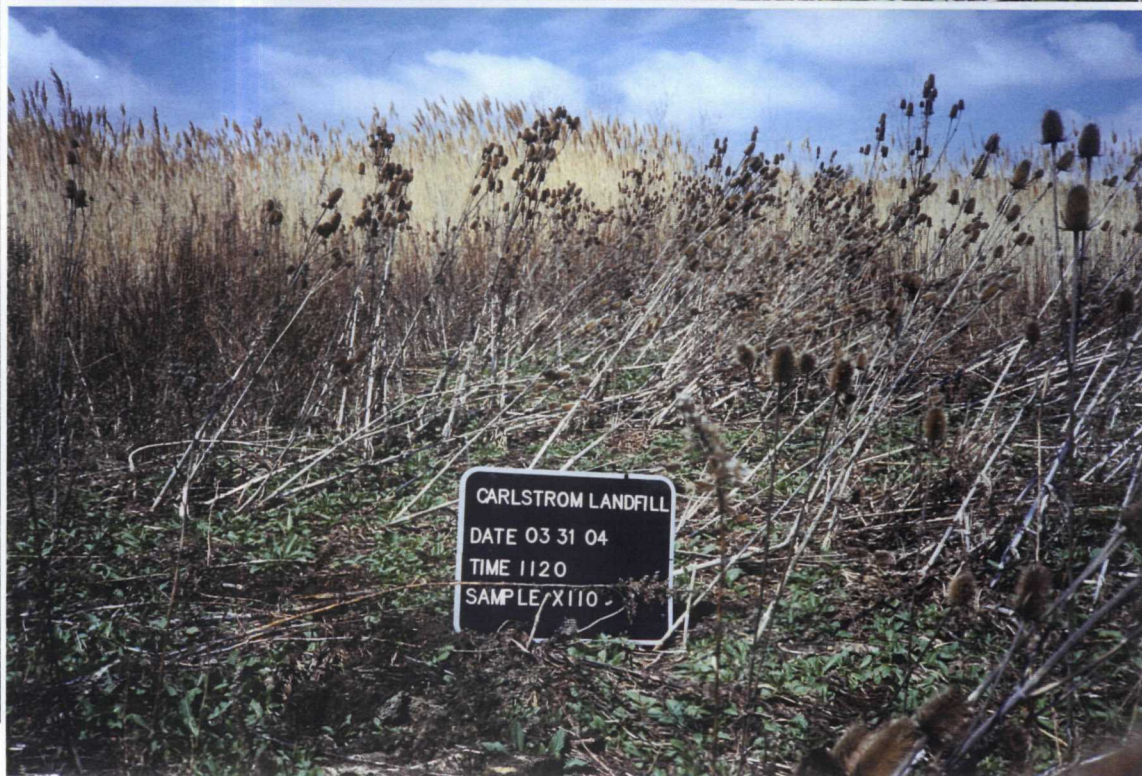
Sample X110. The  
sample was collect-  
ed at the south  
side of the land-  
fill.

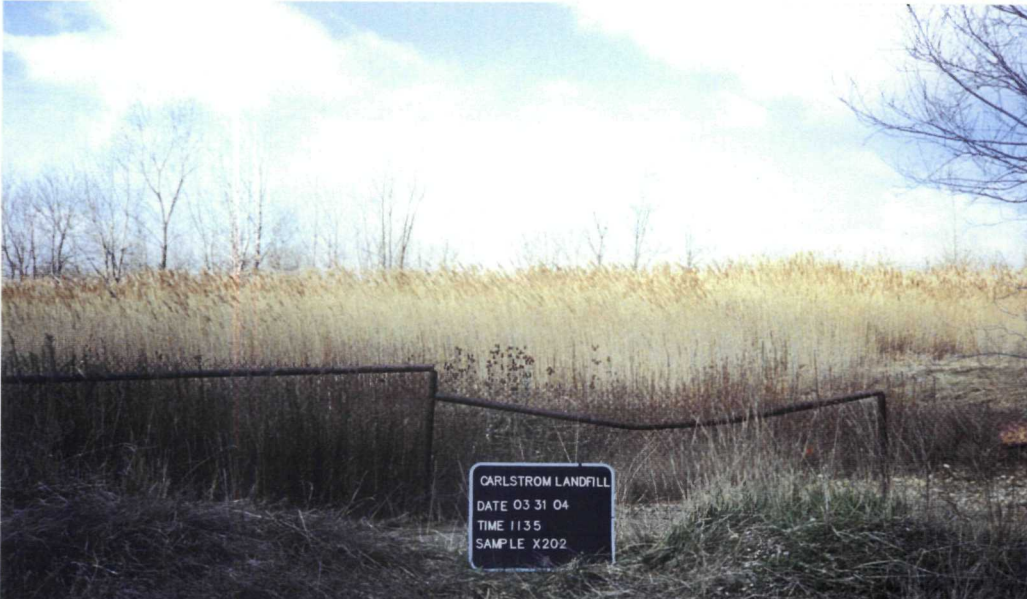
COMMENTS: Picture taken toward: North.		
Photo Number 31.		
Sample X202 was collected at the south side where drainage from the site collects.

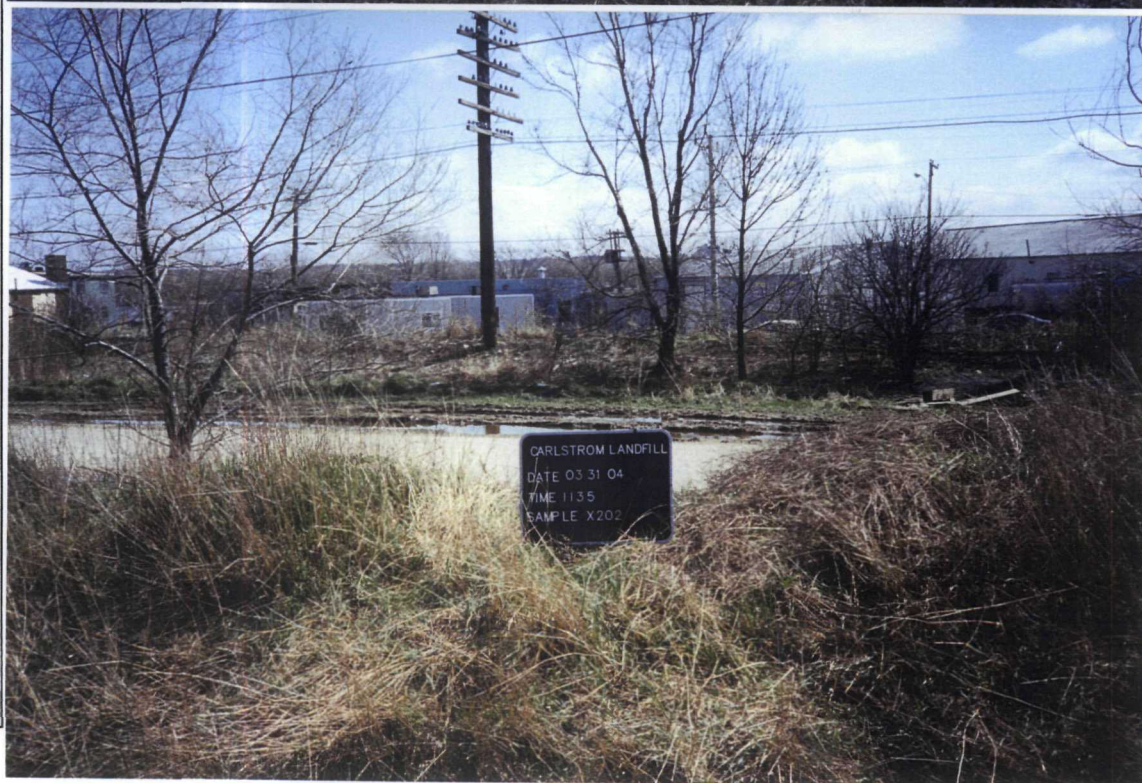
DATE: 3/31/04
TIME: 11:35
PHOTOGRAPH TAKEN BY: R. CASPER
COMMENTS: Picture taken toward: South.
Photo Number 32.
Sample X202. The drainage flows across the road into a ditch along the north side of railroad tracks.

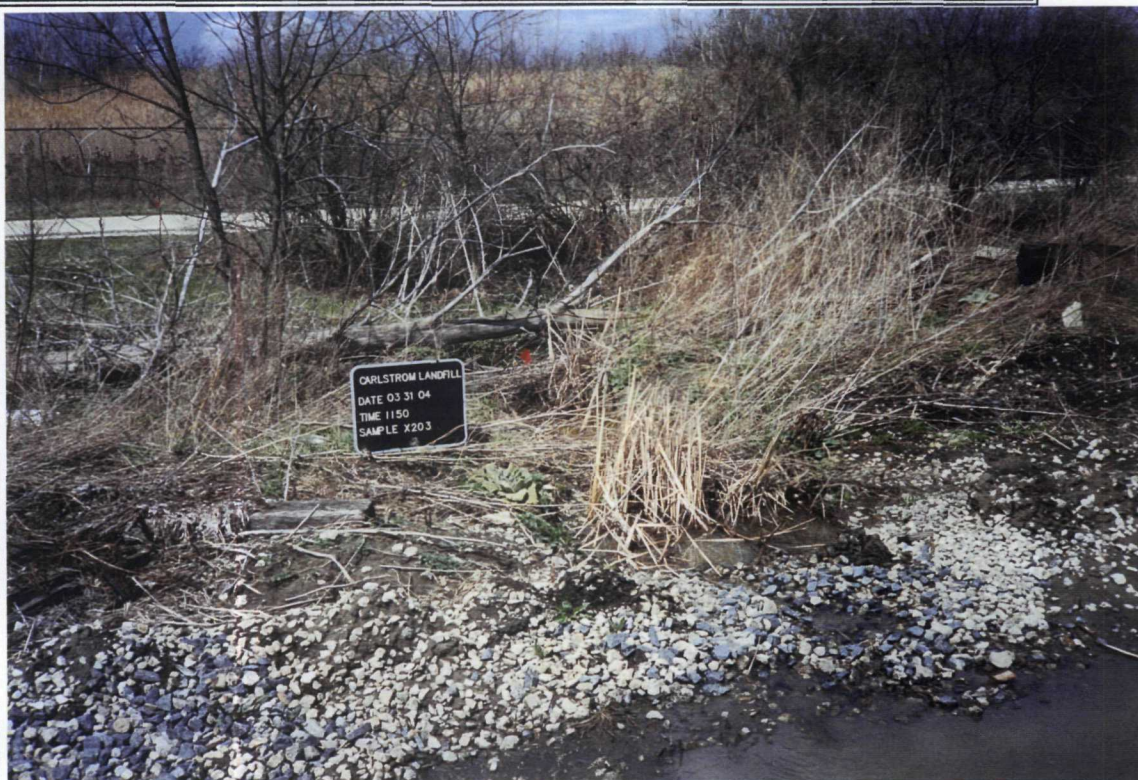
DATE: 3/31/04	SITE IL# #: 980497721	COUNTY: Will
TIME: 11:50	SITE NAME: Carlstrom Landfill	
PHOTOGRAPH TAKEN BY: R. Casper		
COMMENTS: Picture taken toward: North.		
Photo Number 33.		
Sample X203 was collected across the road from the landfill.

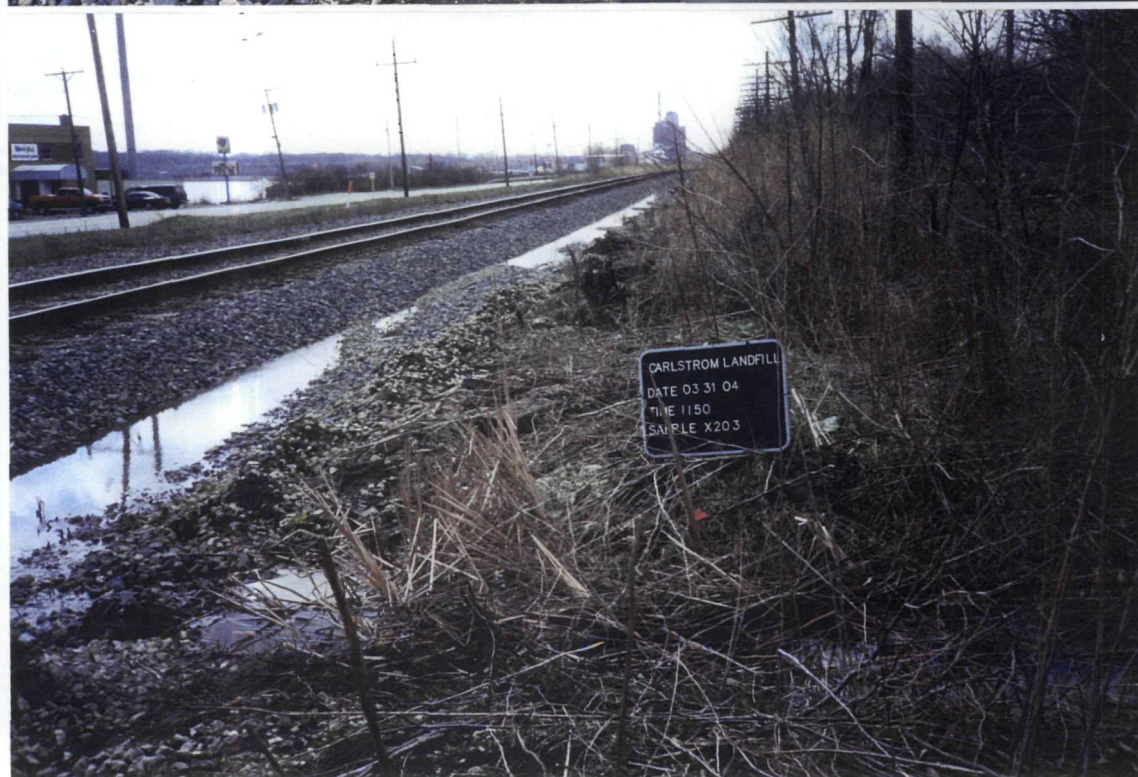
DATE: 3/31/04
TIME: 11:50
PHOTOGRAPH TAKEN BY: R. CASPER
COMMENTS: Picture taken toward: West.
Photo Number 34.
Sample X203. The drainage flows west and eventually enters into the I & M canal.

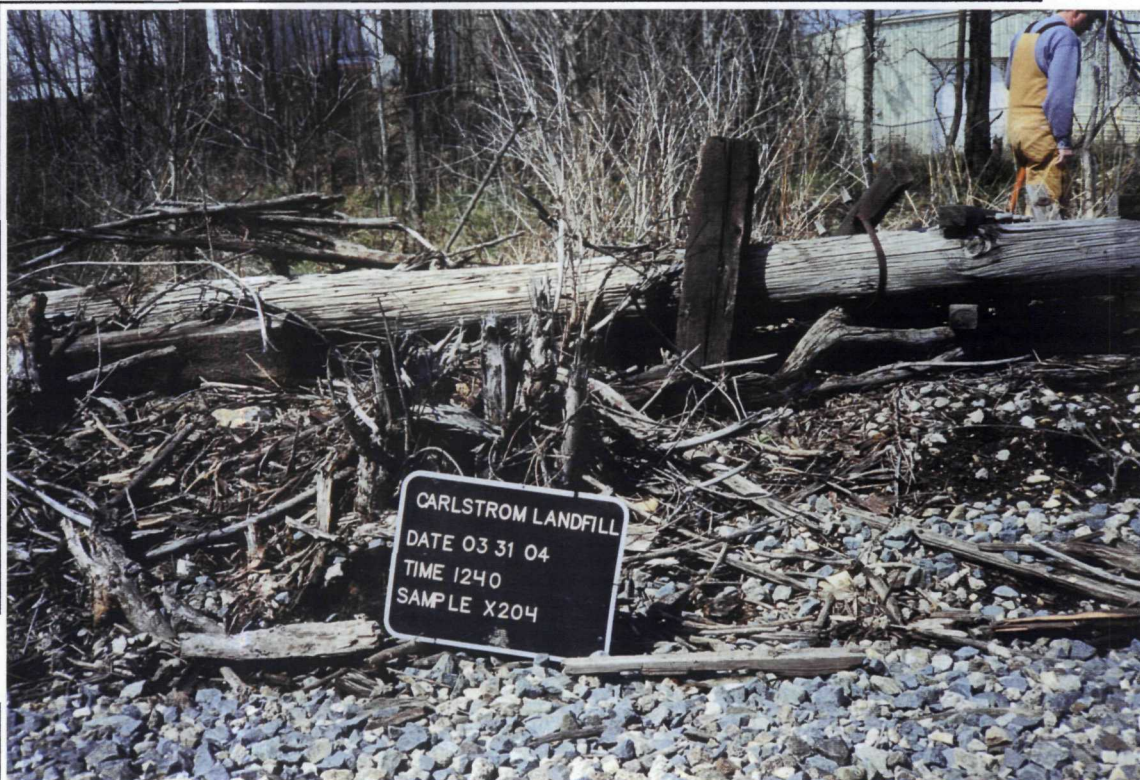
Sample X204 was  
collected in the  
ditch along the  
railroad tracks  
west of the site.

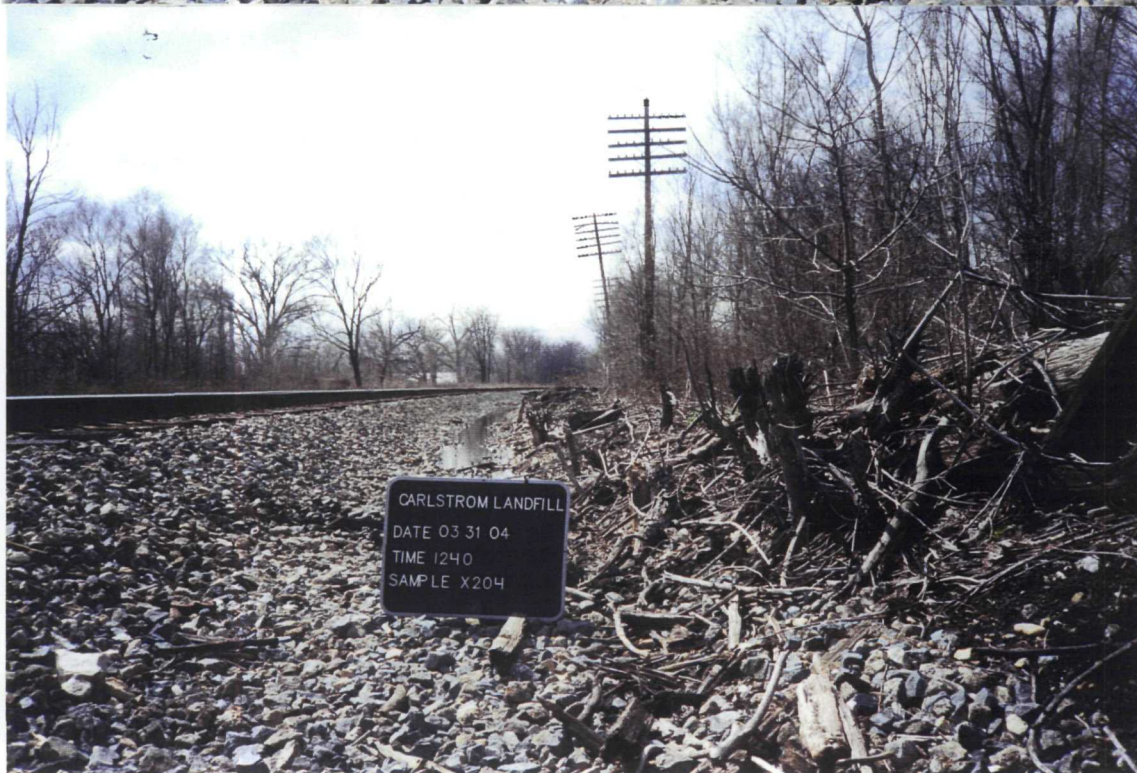
Sample X204. The  
sample was obtained  
below the gravel.  
The water soaks  
into the gravel  
in some areas.

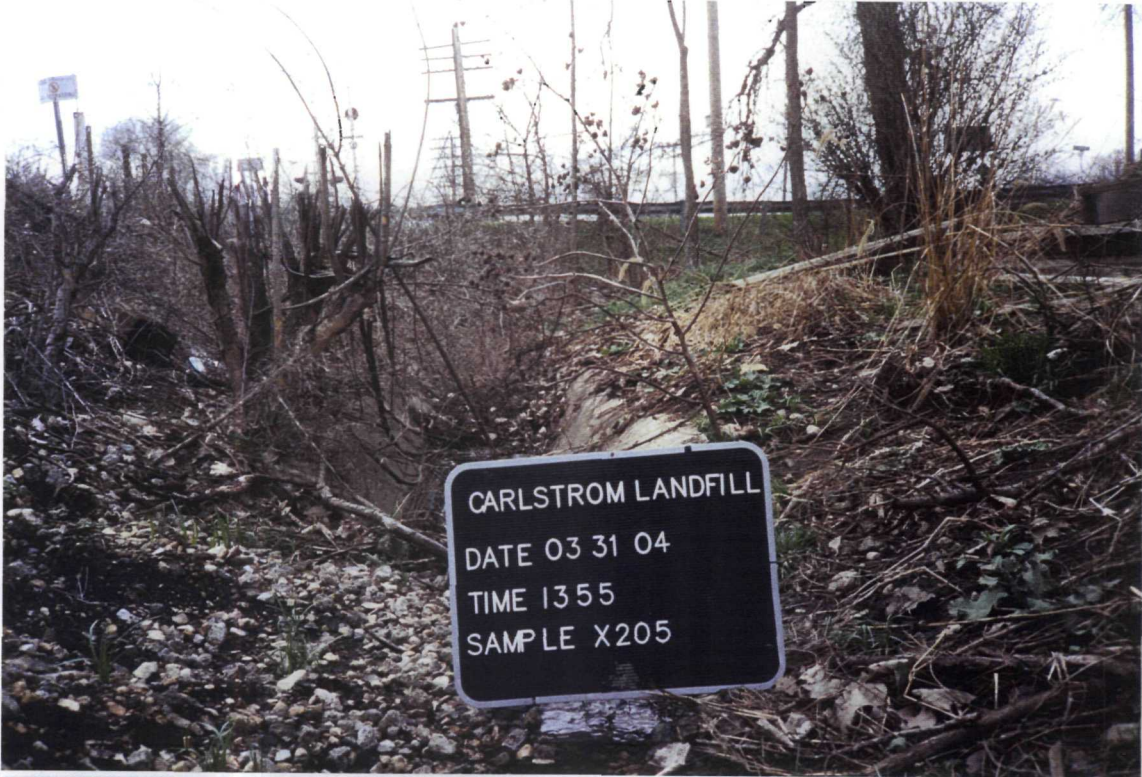
COMMENTS: Picture taken toward: West.		
Photo Number 37.		
Sample X205. The ditch drains into		
Thorne Creek along		
Brandon Road, located at top.

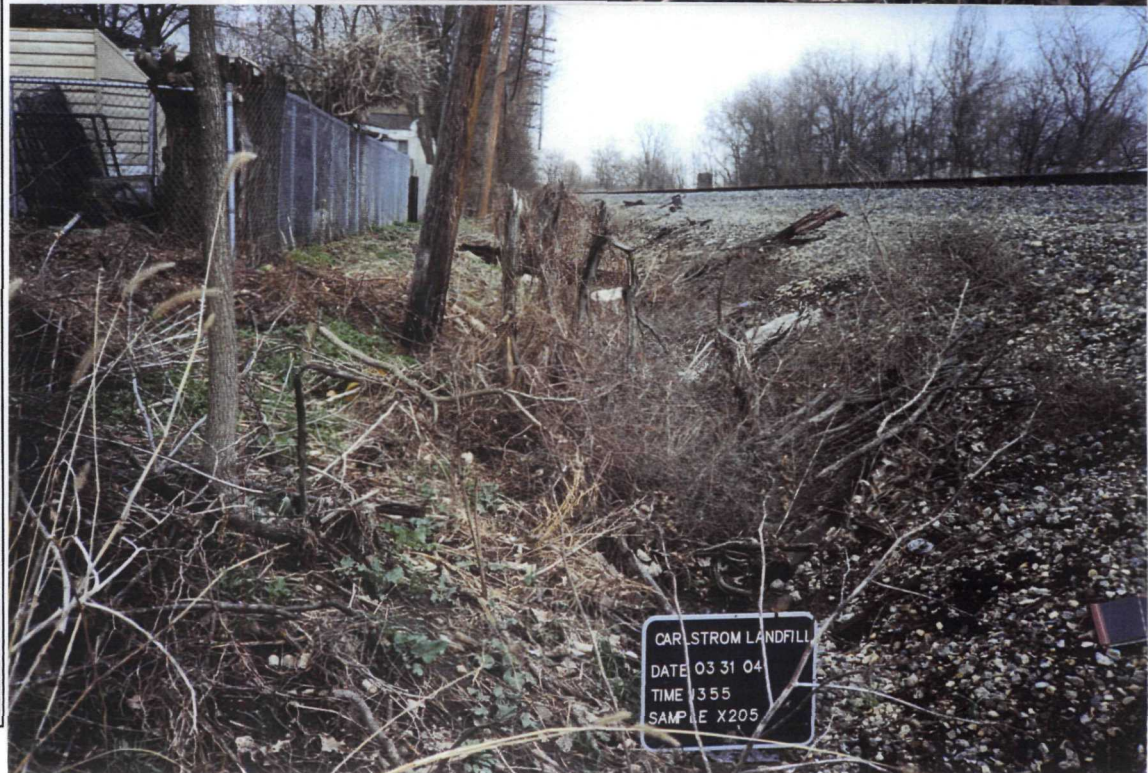
DATE: 3/31/04
TIME: 13:55
PHOTOGRAPH TAKEN BY: R. CASPER
COMMENTS: Picture taken toward: East.
Photo Number 38.
Sample X205. The site is located approximately
3,000 feet away.

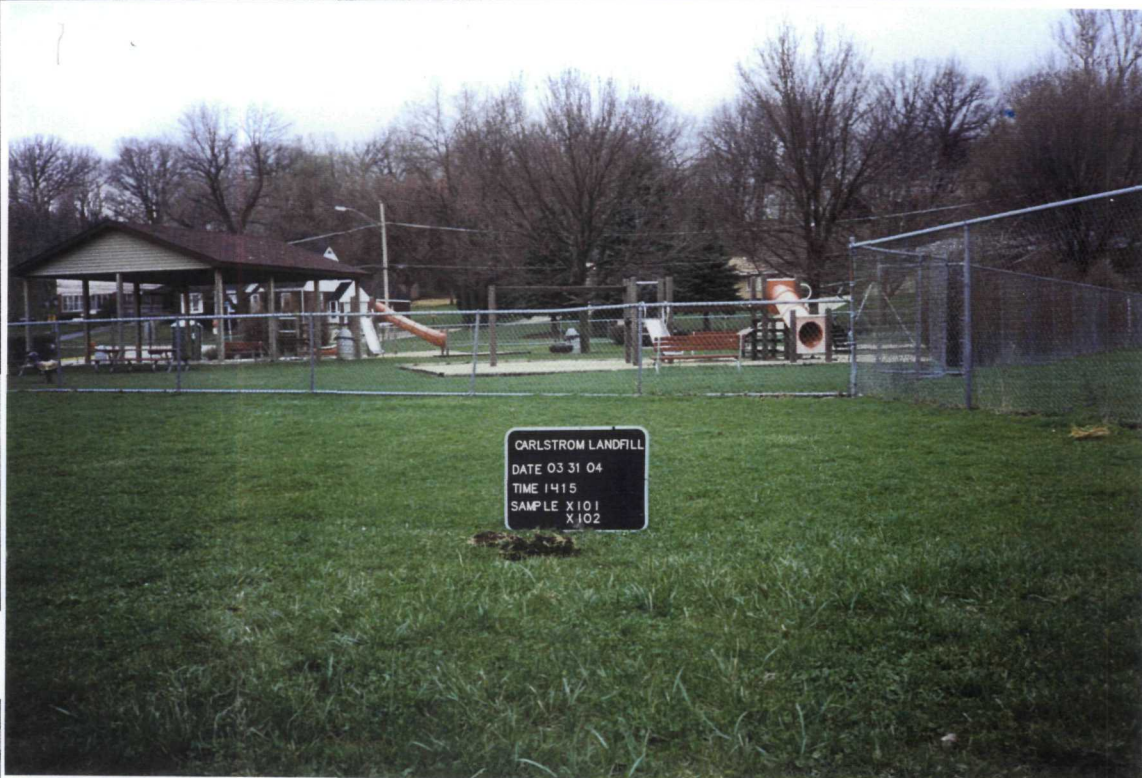
DATE: 3/31/04	SITE ILD#: 980497721	COUNTY: Will
TIME: 14:15	SITE NAME: Carlstrom Landfill	
PHOTOGRAPH TAKEN BY: R. Casper		
COMMENTS: Picture taken toward: North.		
Photo Number 39.		
Sample X101/X102.		
Background samples collected at Rockdale Village Park, ~3,000 feet west.

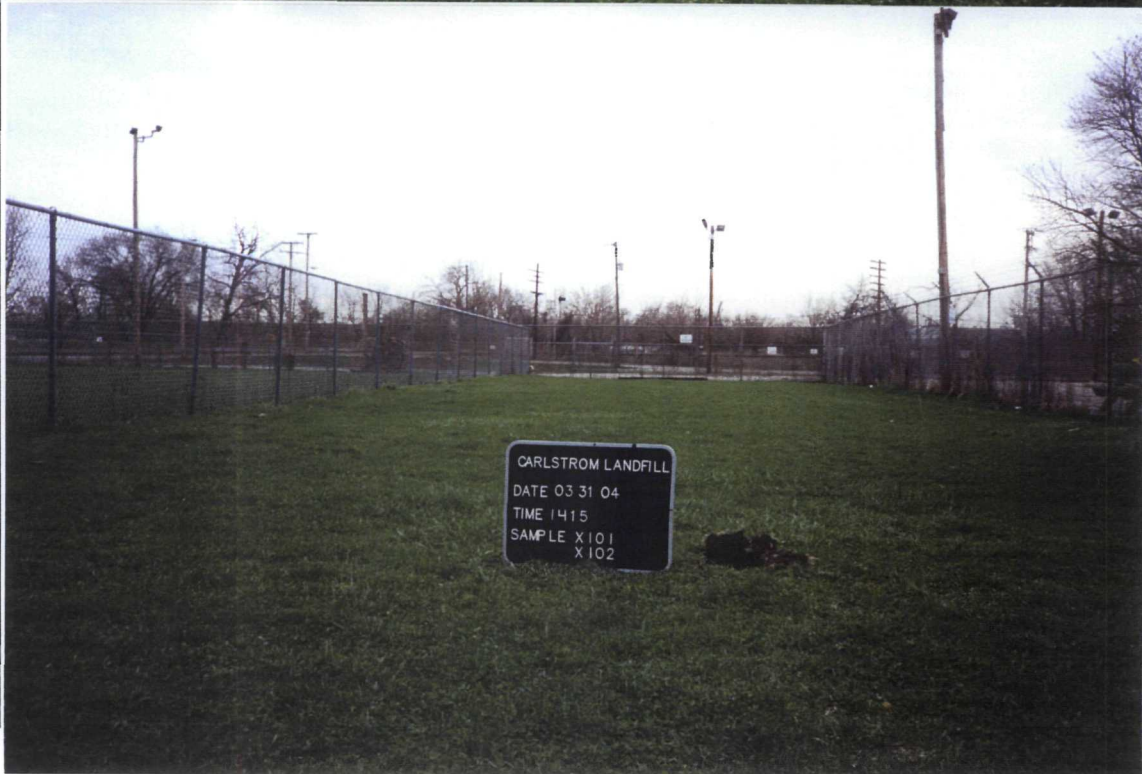
DATE: 3/31/04
TIME: 14:15
PHOTOGRAPH TAKEN BY: R. CASPER
COMMENTS: Picture taken toward: South.
Photo Number 40.
Sample X101/X102.
These are duplicate samples collected from a black loam.

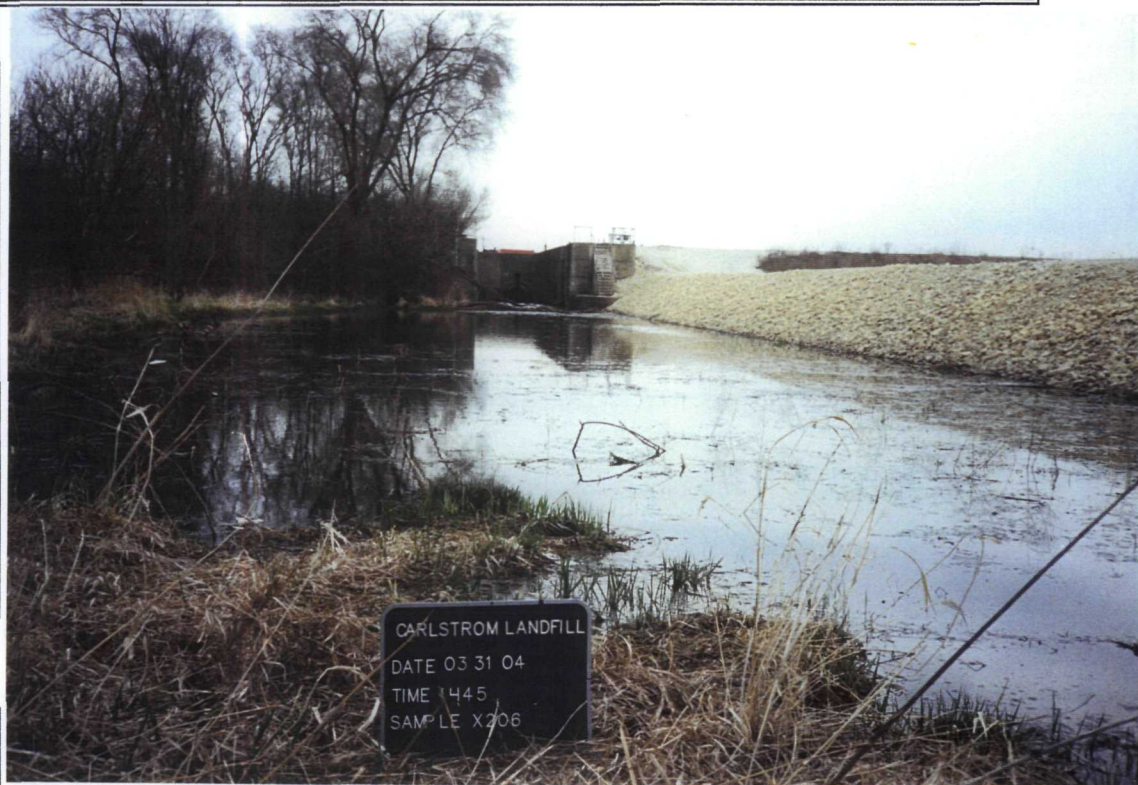
Sample X206 was  
collected from the  
I & M Canal. The  
lock at top enters  
the Des Plaines R.

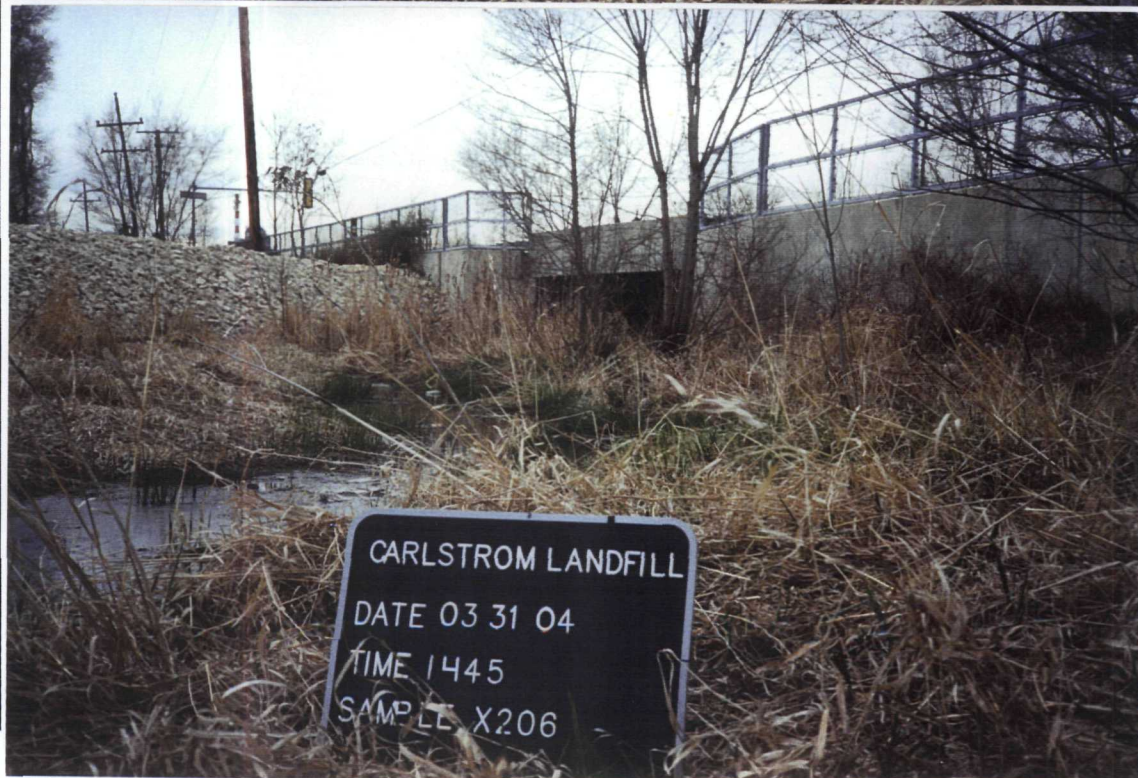
Sample X206. The  
canal goes under  
the Route 6 bridge  
and continues  
west.

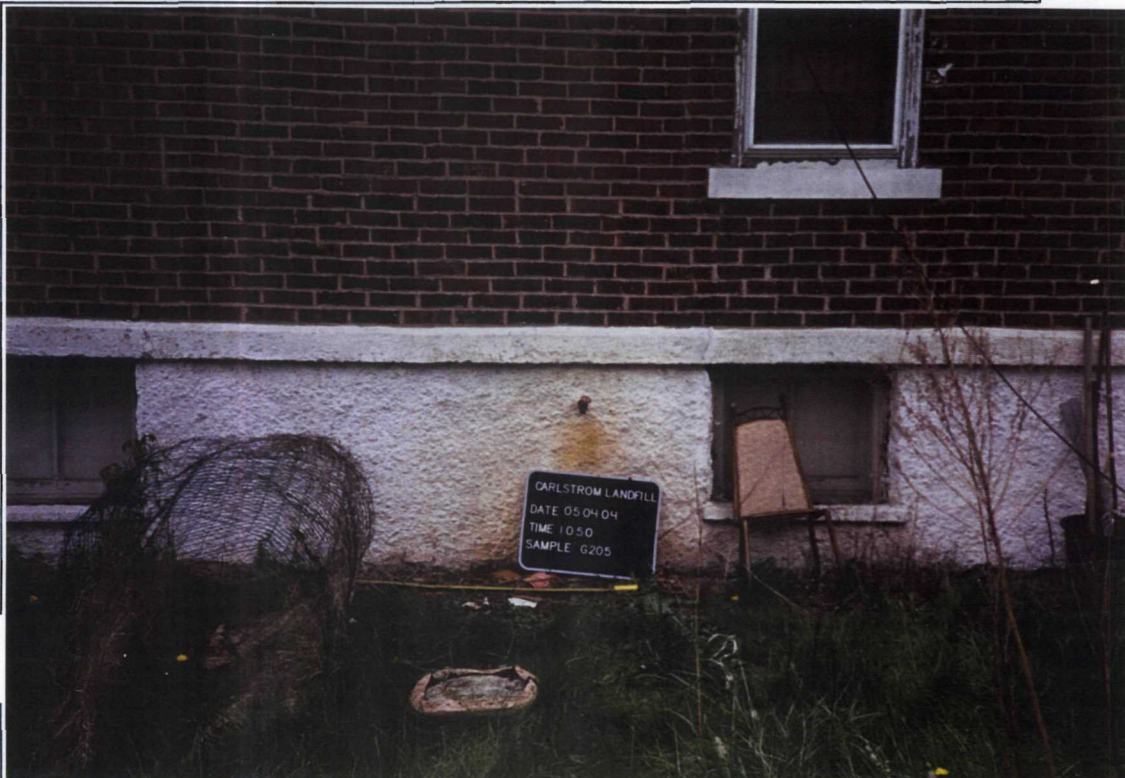
DATE: 5/4/04	SITE IL# #: 980497721	COUNTY: Will
TIME: 10:50	SITE NAME: Carlstrom Landfill	
PHOTOGRAPH TAKEN BY: R. Casper		
COMMENTS: Picture taken toward: South.		
Photo Number 43.		
Sample G205 was collected from a private residential well located 300 feet east of site.

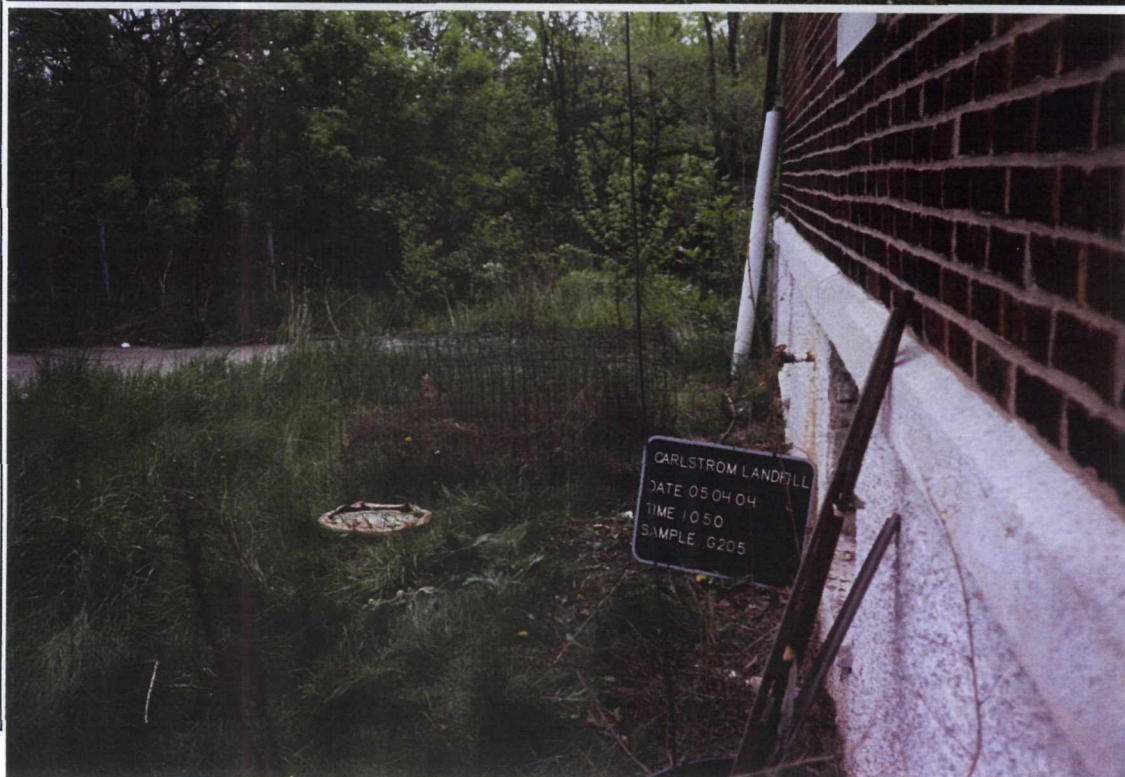
DATE: 5/4//04
TIME: 10:50
PHOTOGRAPH TAKEN BY: R. CASPER
COMMENTS: Picture taken toward: East.
Photo Number 44.
Sample G205.
Interstate 80 is located approximately 100 feet beyond the trees in the background.

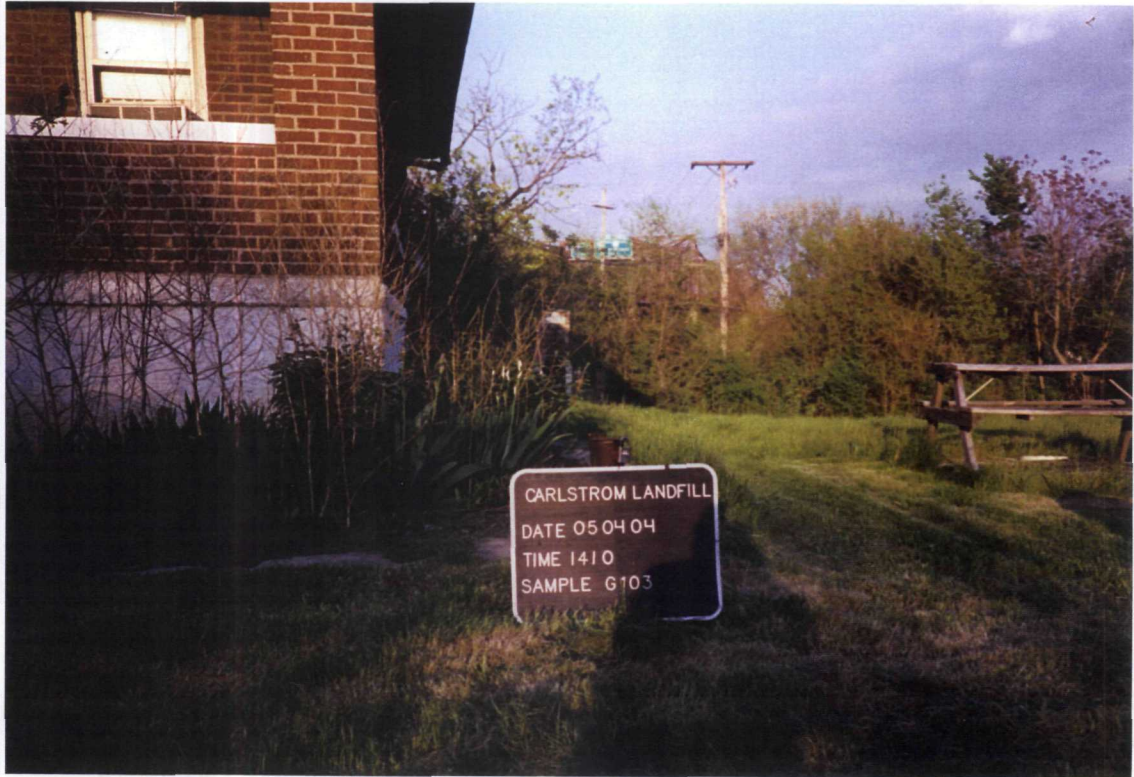
DATE: 5/4/04	SITE ILID#: 980497721	COUNTY: Will
TIME: 14:10	SITE NAME: Carlstrom Landfill	
PHOTOGRAPH TAKEN BY: R. Casper		
COMMENTS: Picture taken toward: East.		
Photo Number 45.		
Sample G103 was collected from a 115 feet deep monitoring well near location G205.

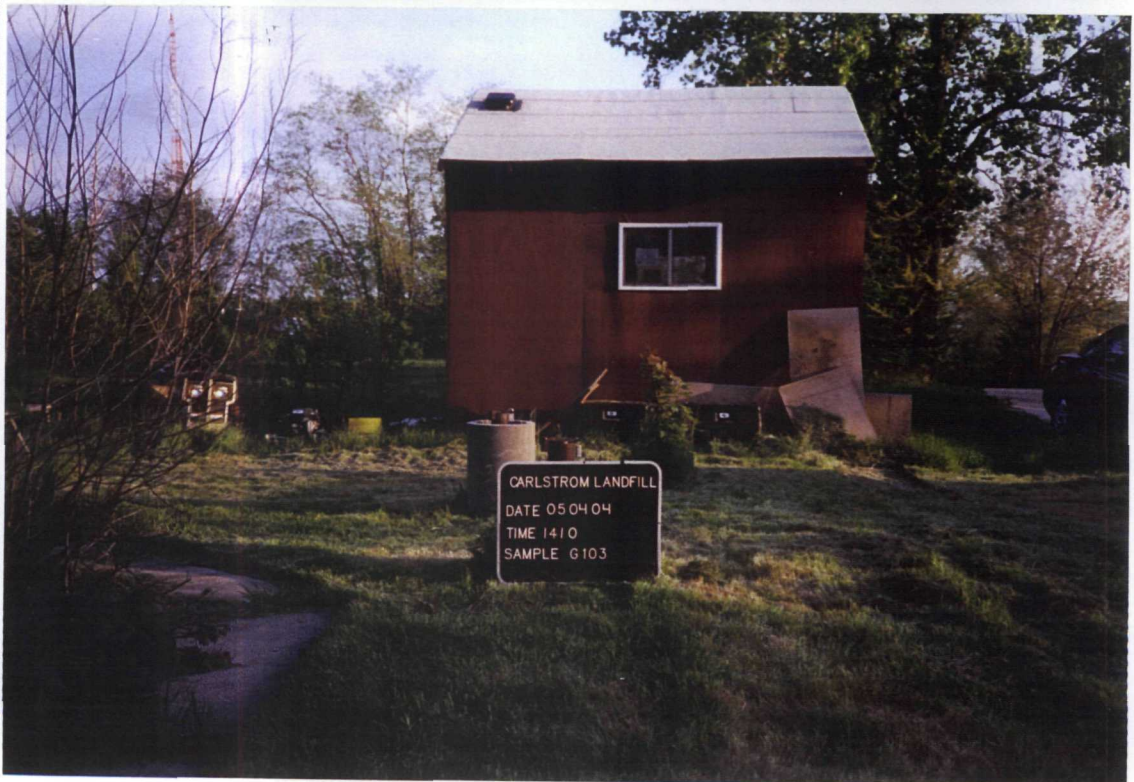
DATE: 5/4//04
TIME: 14:10
PHOTOGRAPH TAKEN BY: R. CASPER
COMMENTS: Picture taken toward: South.
Photo Number 46.
Sample G103. The landfill is aproxi- mately 200 feet to the right. Well G104 is visible behind photo board.

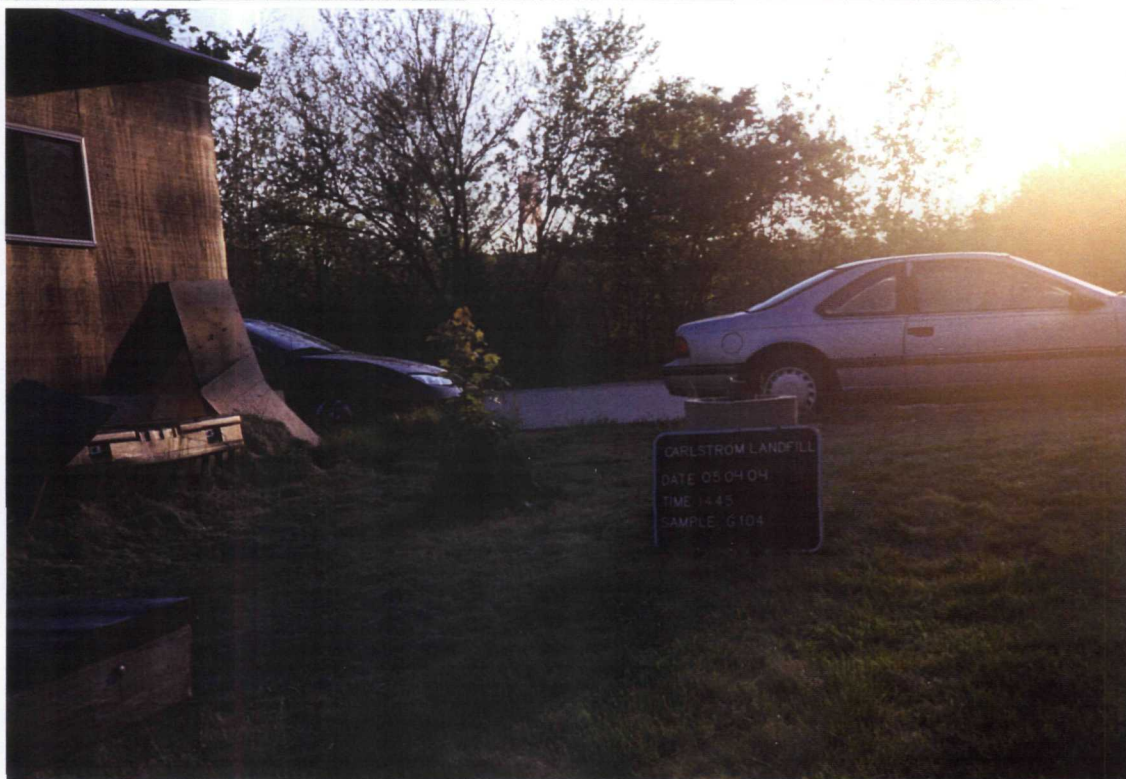
DATE: 5/4/04	SITE IL# #: 980497721	COUNTY: Will
TIME: 14:45	SITE NAME: Carlstrom Landfill	
PHOTOGRAPH TAKEN BY: R. Casper		
COMMENTS: Picture taken toward: West.		
Photo Number 47.		
Sample G104 was collected from a 65 feet deep monitoring well near G103.

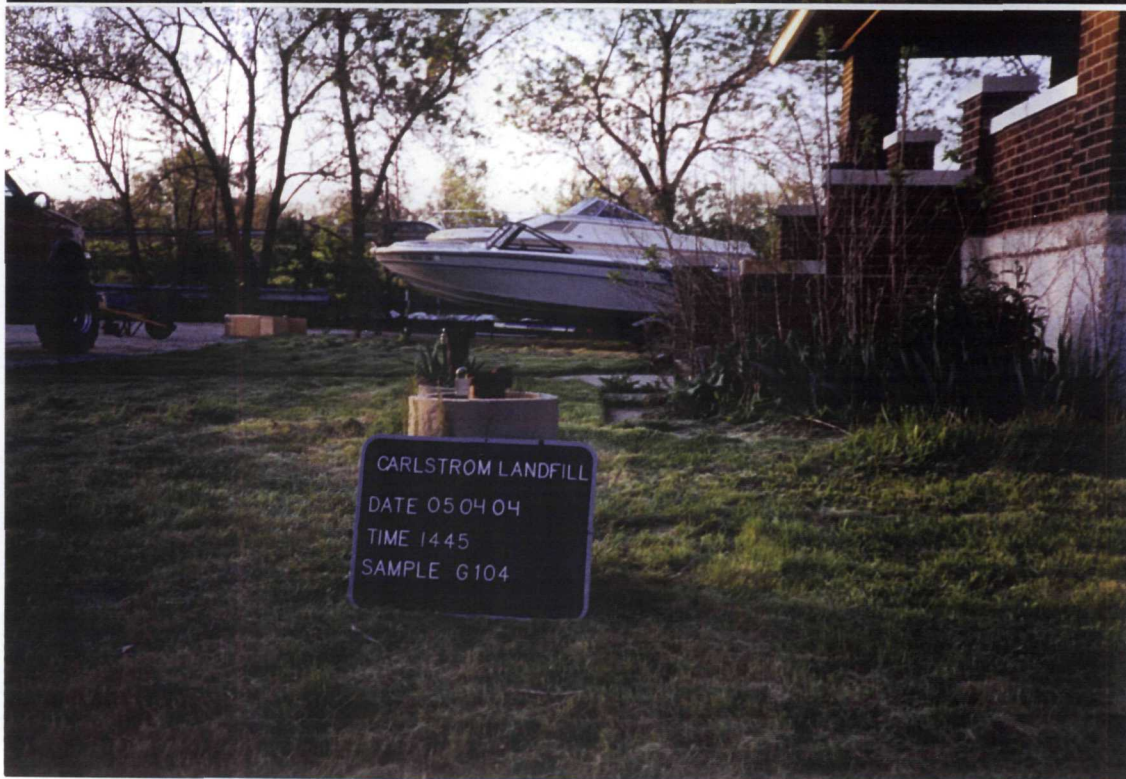
DATE: 5/4//04
TIME: 14:45
PHOTOGRAPH TAKEN BY: R. CASPER
COMMENTS: Picture taken toward: North.
Photo Number 48.
Sample G104. The well is one of a cluster two monitoring wells constructed in 1989.

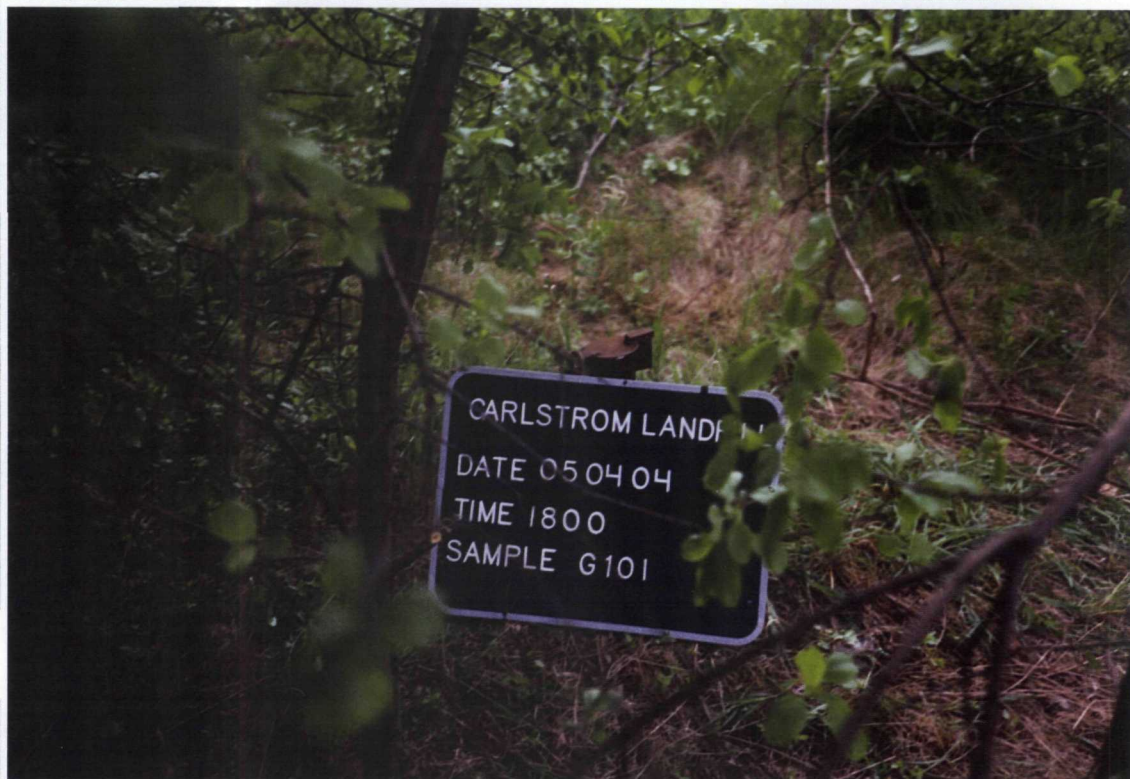
PHOTOGRAPH TAKEN BY: R. Casper
COMMENTS: Picture taken toward: North.
Photo Number 49.
Sample G101 was collected from an onsite monitoring well located at the north side of site.

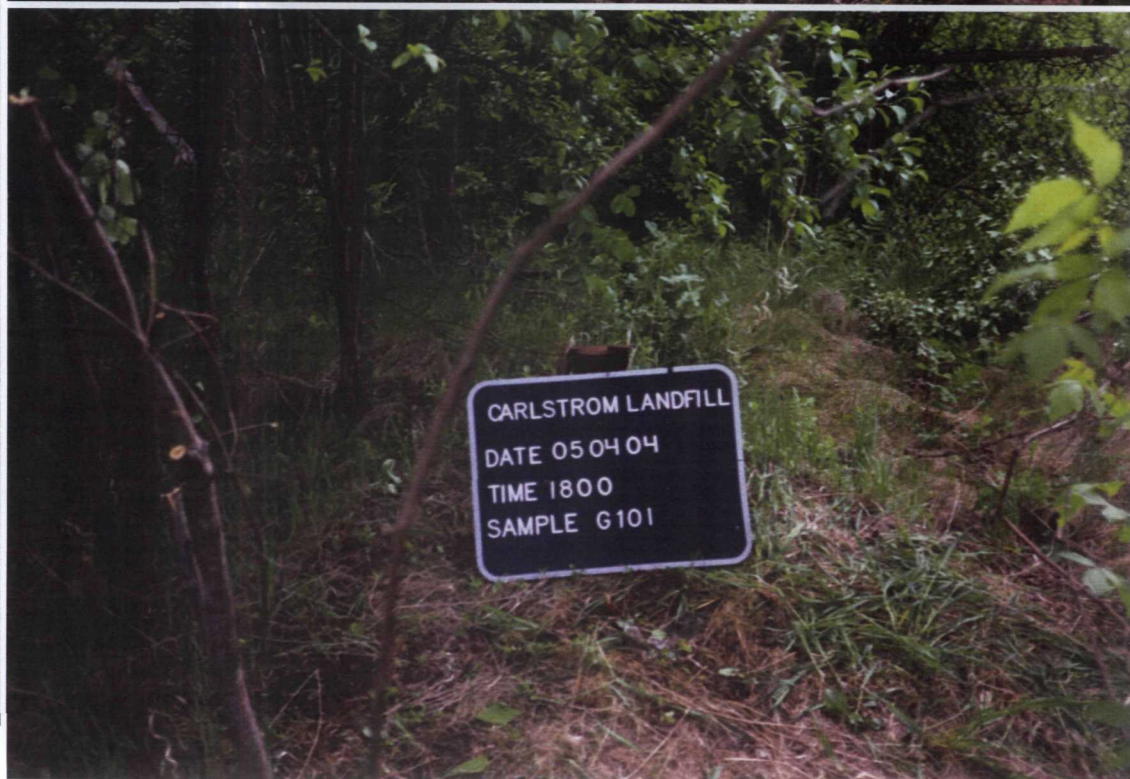
DATE: 5/4//04
TIME: 18:00
PHOTOGRAPH TAKEN BY: R. CASPER
COMMENTS: Picture taken toward: West.
Photo Number 50.
Sample G101. The well is approxi- mately 101.5 feet deep and was originally used as a background well.
